Manhole Inspection Summary

Manhole # S21WW1060MH

Insp Date: **5/8/07 2:21 PM**

Location Address: **CROSS KEYS RD**

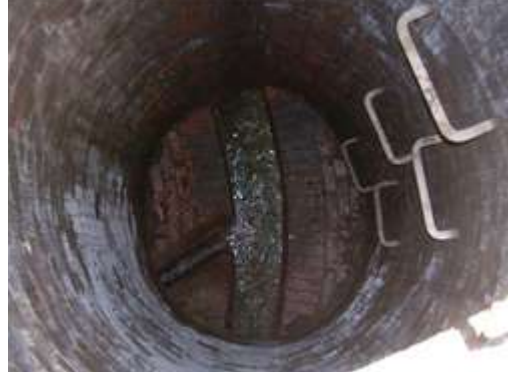
Top View

Evidence of surcharge - Bench debris.

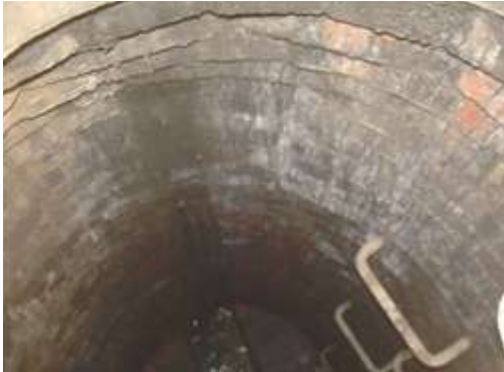
Defect

Frame leaks. Corbel and Barrel infiltration.

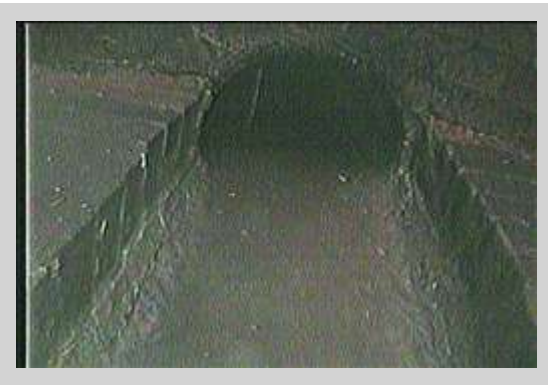
12 in. Circular Gravity Sewer Pipe Out @ 12 O'Clock

Infiltration: **Evidence** Pipe Seal Cond: **Cracked**

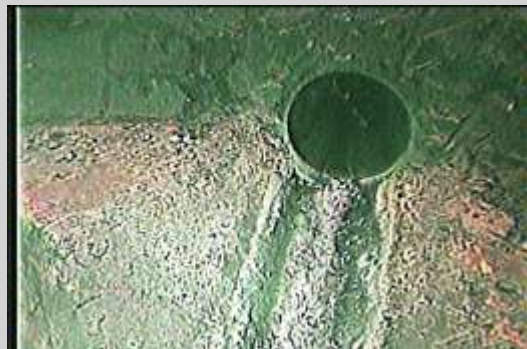
6 in. Circular Gravity Sewer

Barrel deterioration and infiltration.

Pipe Seal Cond: **Cracked**
